American Civil War Fortifications (1)

Coastal brick and stone forts

Series editors Marcus Cowper and Nikolai Bogdanovic

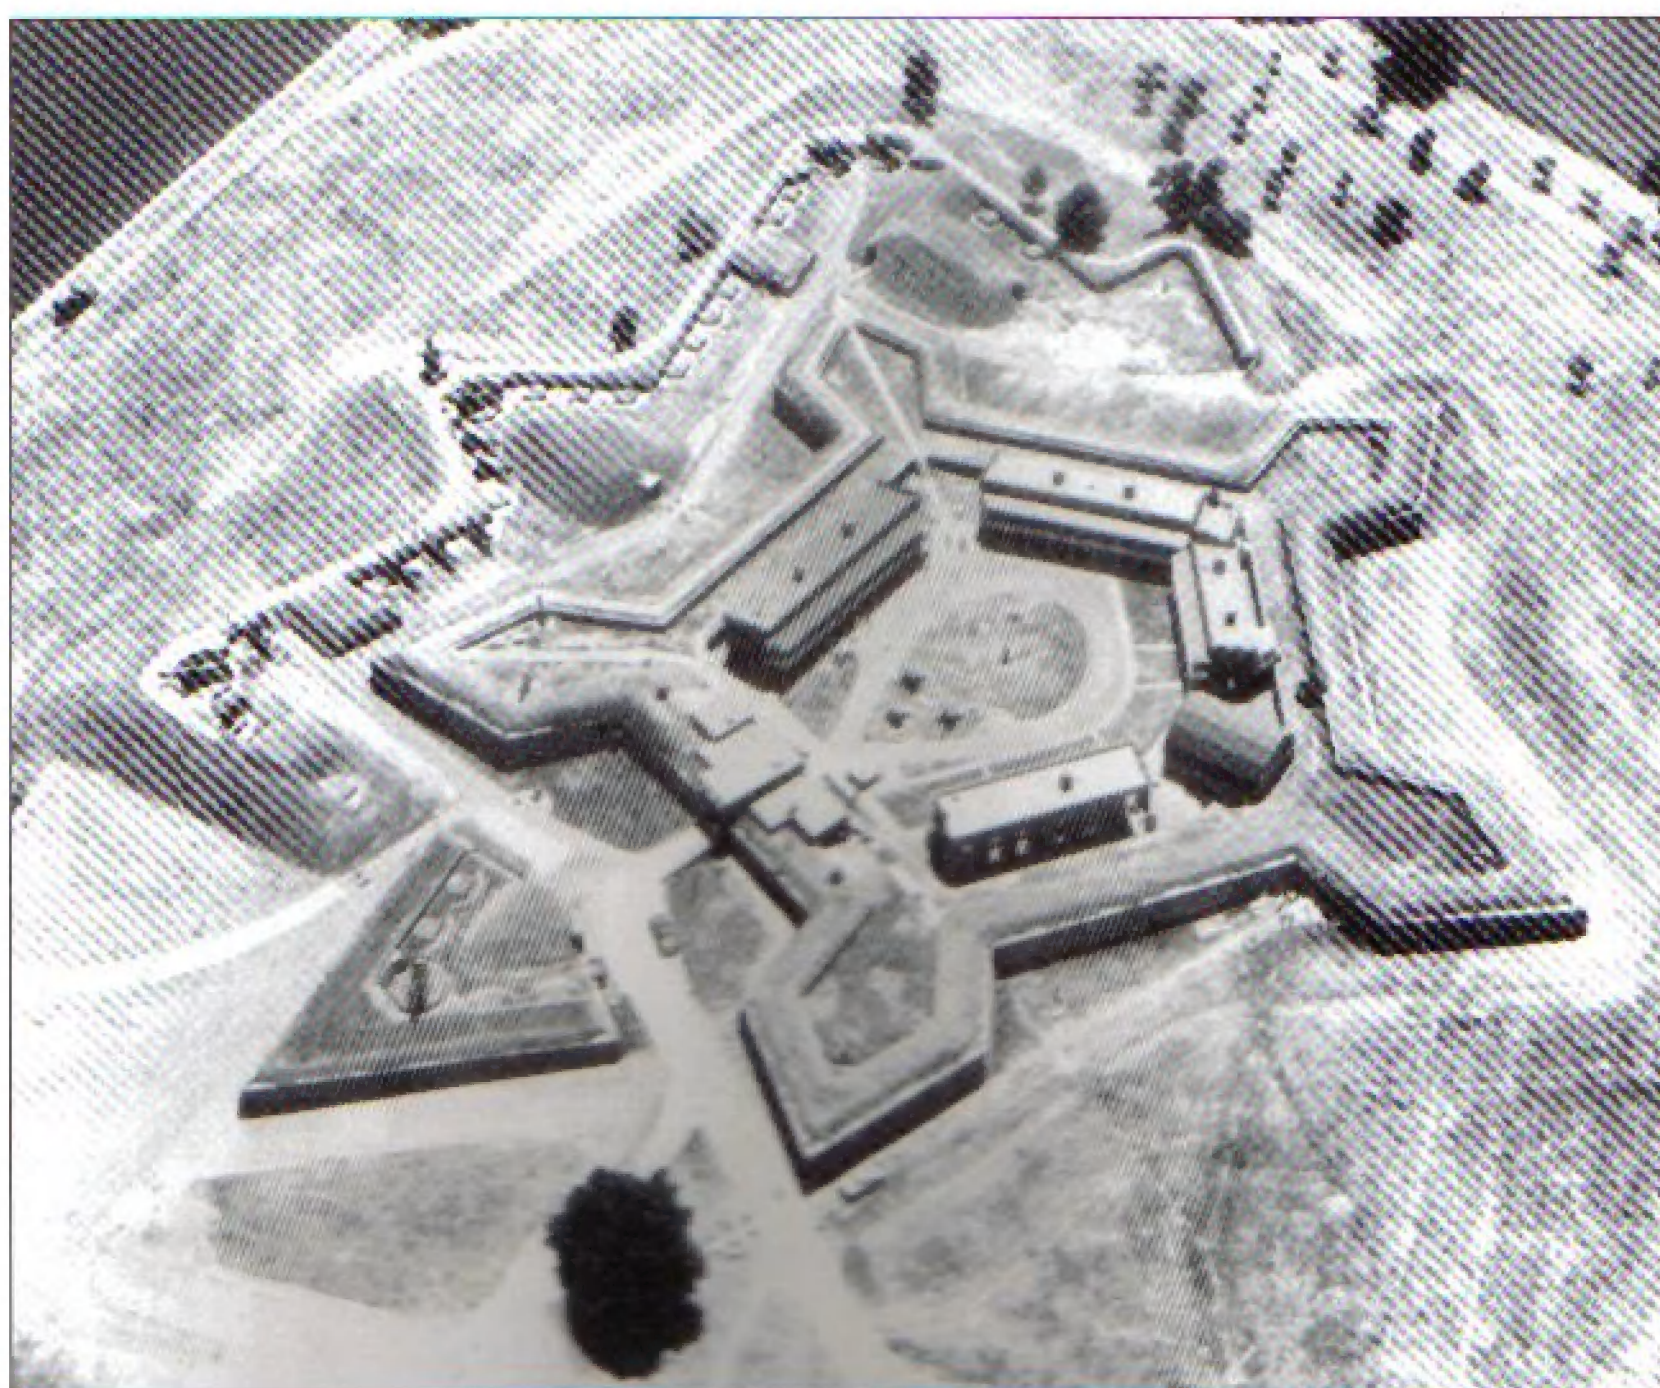
Fort McHenry was first built around 1800 to defend Baltimore Harbor, and became famous in 1813 when it resisted a furious British bombardment. The action inspired the composition of "The Star Spangled Banner." Third System-era outer works augmented the initial five-pointed Second System fortification. (Clyde Hensley Collection)

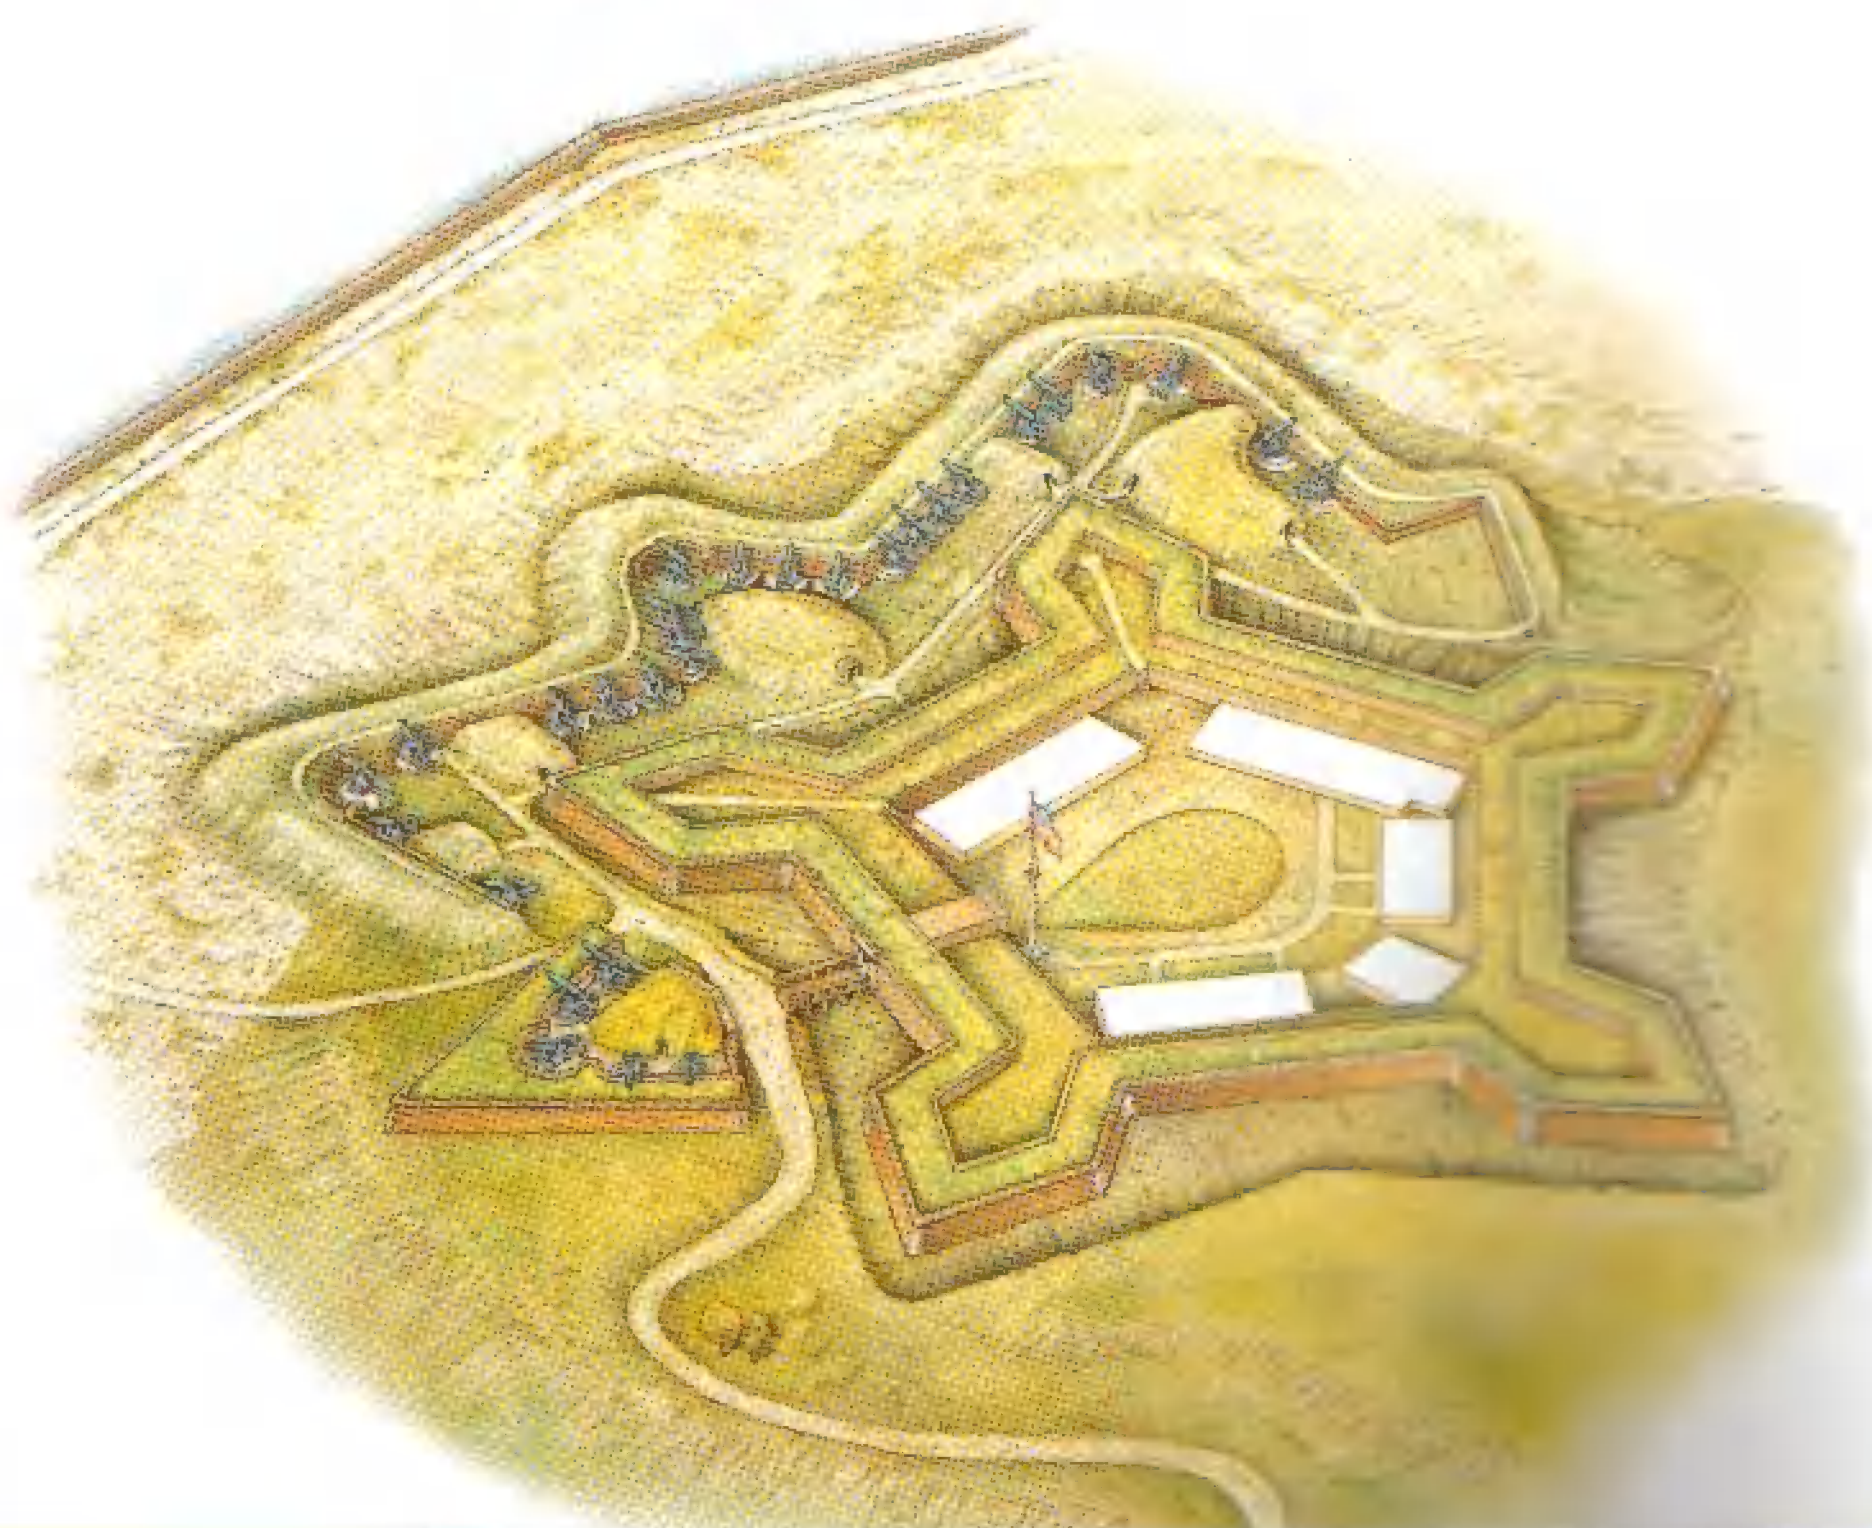
Forts Marion and McHenry

Many forts built before the Third System of fortifications was introduced were converted to conform to the latest notions of coastal defense. Fort Marion (**top**), at St. Augustine, Florida was the oldest example of these refurbished coastal fortifications. Built as the Castillo de San Marcos by the Spanish in 1672, the fort was built along classical Vauban lines, and the modernization was limited to the addition of outer works, and the emplacement of more modern guns. Similarly Fort McHenry (**bottom**) played a major part in the War of 1812, and was then brought up to date in the same manner during the mid-19th century.

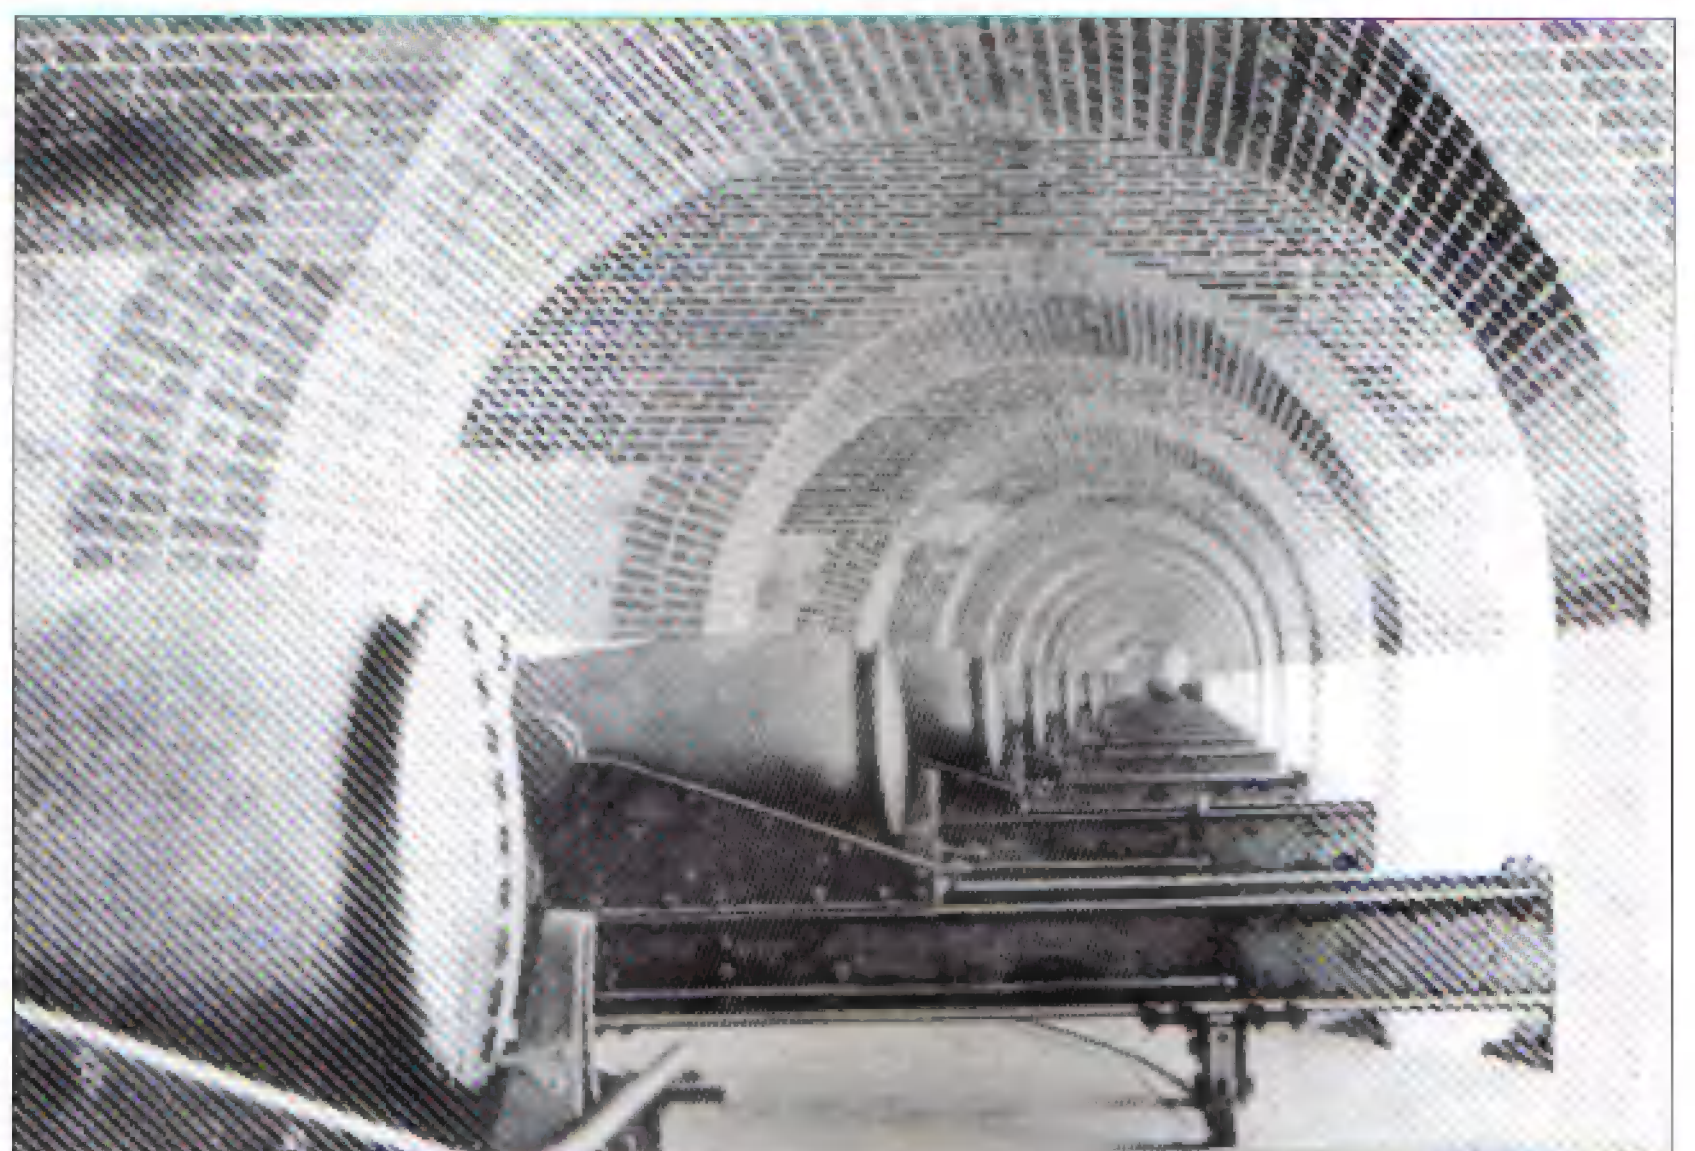
Smoothbore columbiad pieces mounted on iron casemate carriages in the water battery of Fort Monroe, Virginia, photographed shortly after the Civil War. Note the unusual color scheme of the fort, where the lower casemate walls have been painted white. (Estate of Wright Langley)

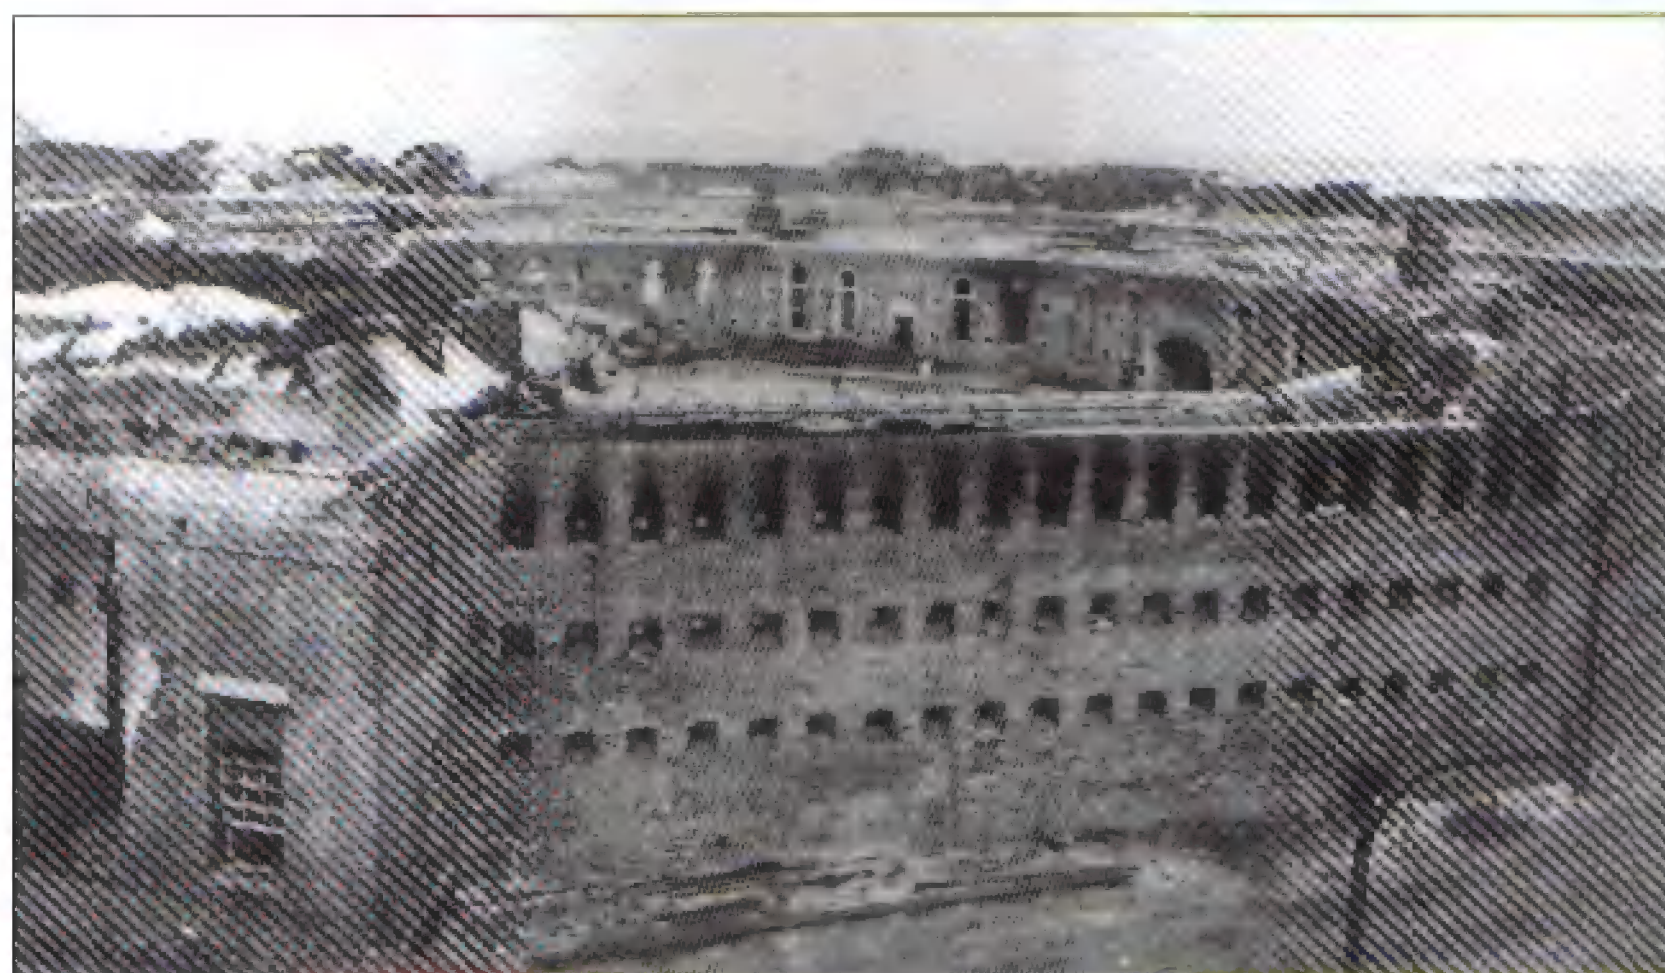
Fort Morgan, Mobile Bay, Alabama, photographed from the nearby lighthouse after her surrender to Union forces in August 1864. The damage inflicted on the fort by the Union fleet was concentrated on the upper works, and the southwestern seaward scarp. (Salamander Archives)

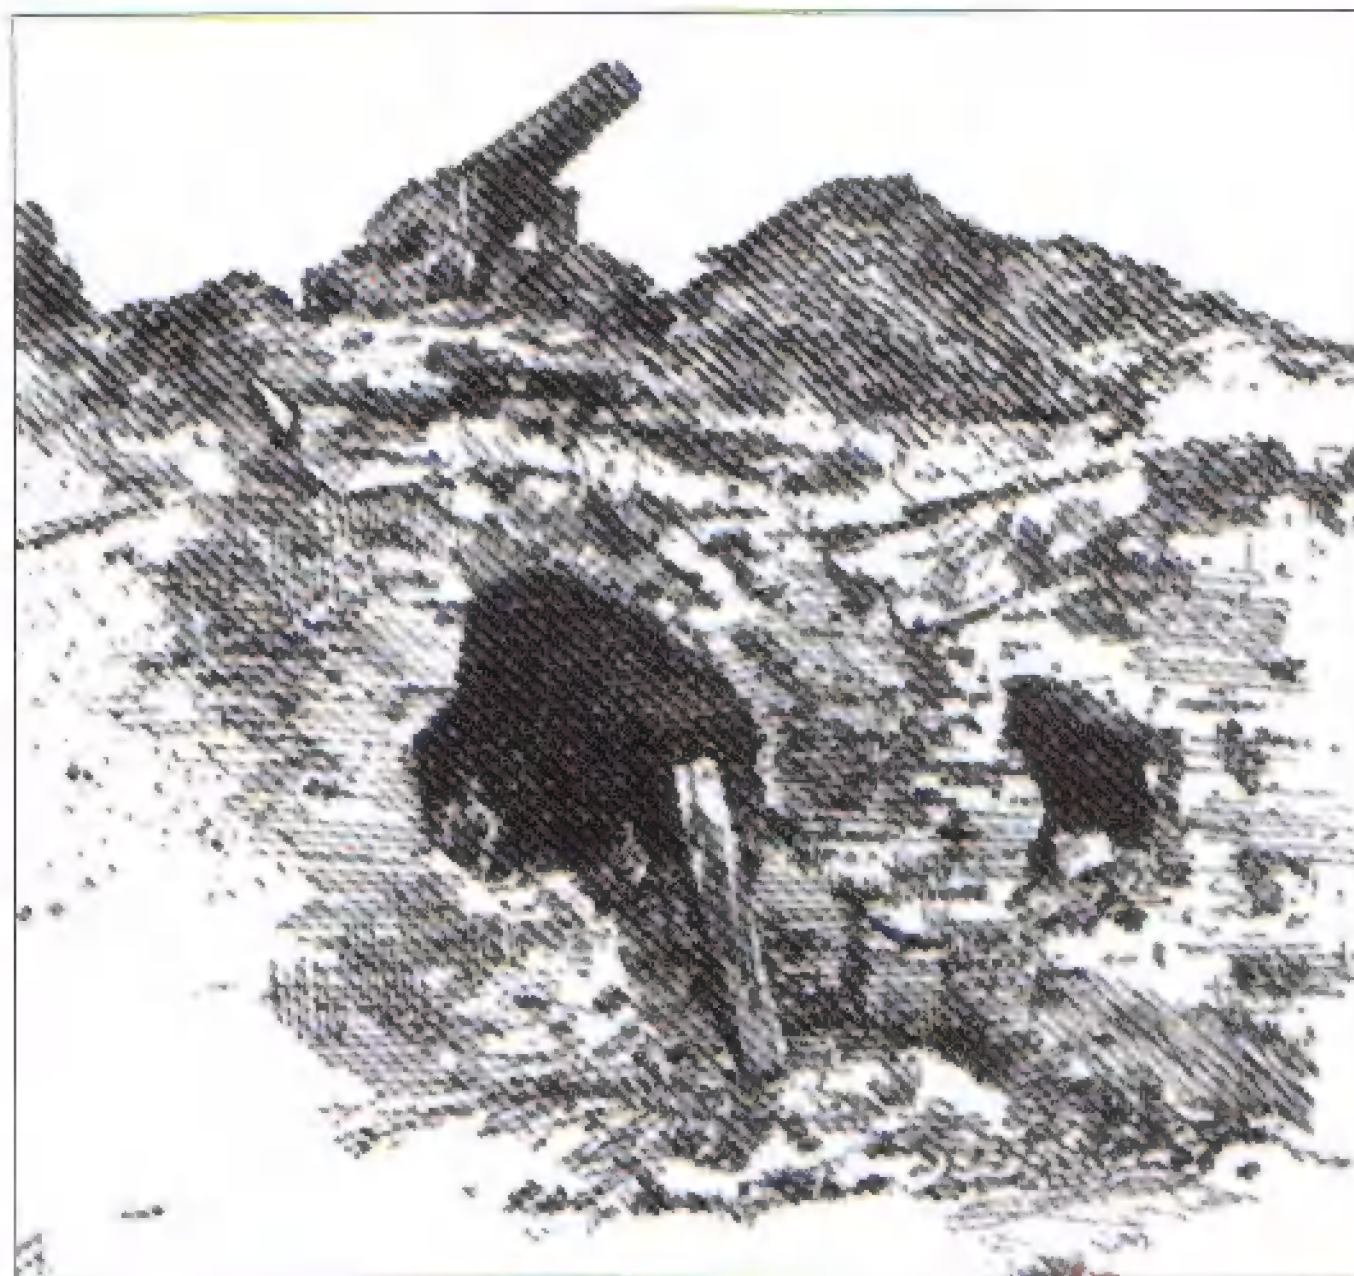
A solitary medium smoothbore gun (probably a 36-pounder) mounted on an *en barbette* carriage remains in place after the scarp protecting the casemates and the rampart and superior slope covering the terreplein of Fort Pulaski were demolished by Union rifled guns. (Stratford Archive)

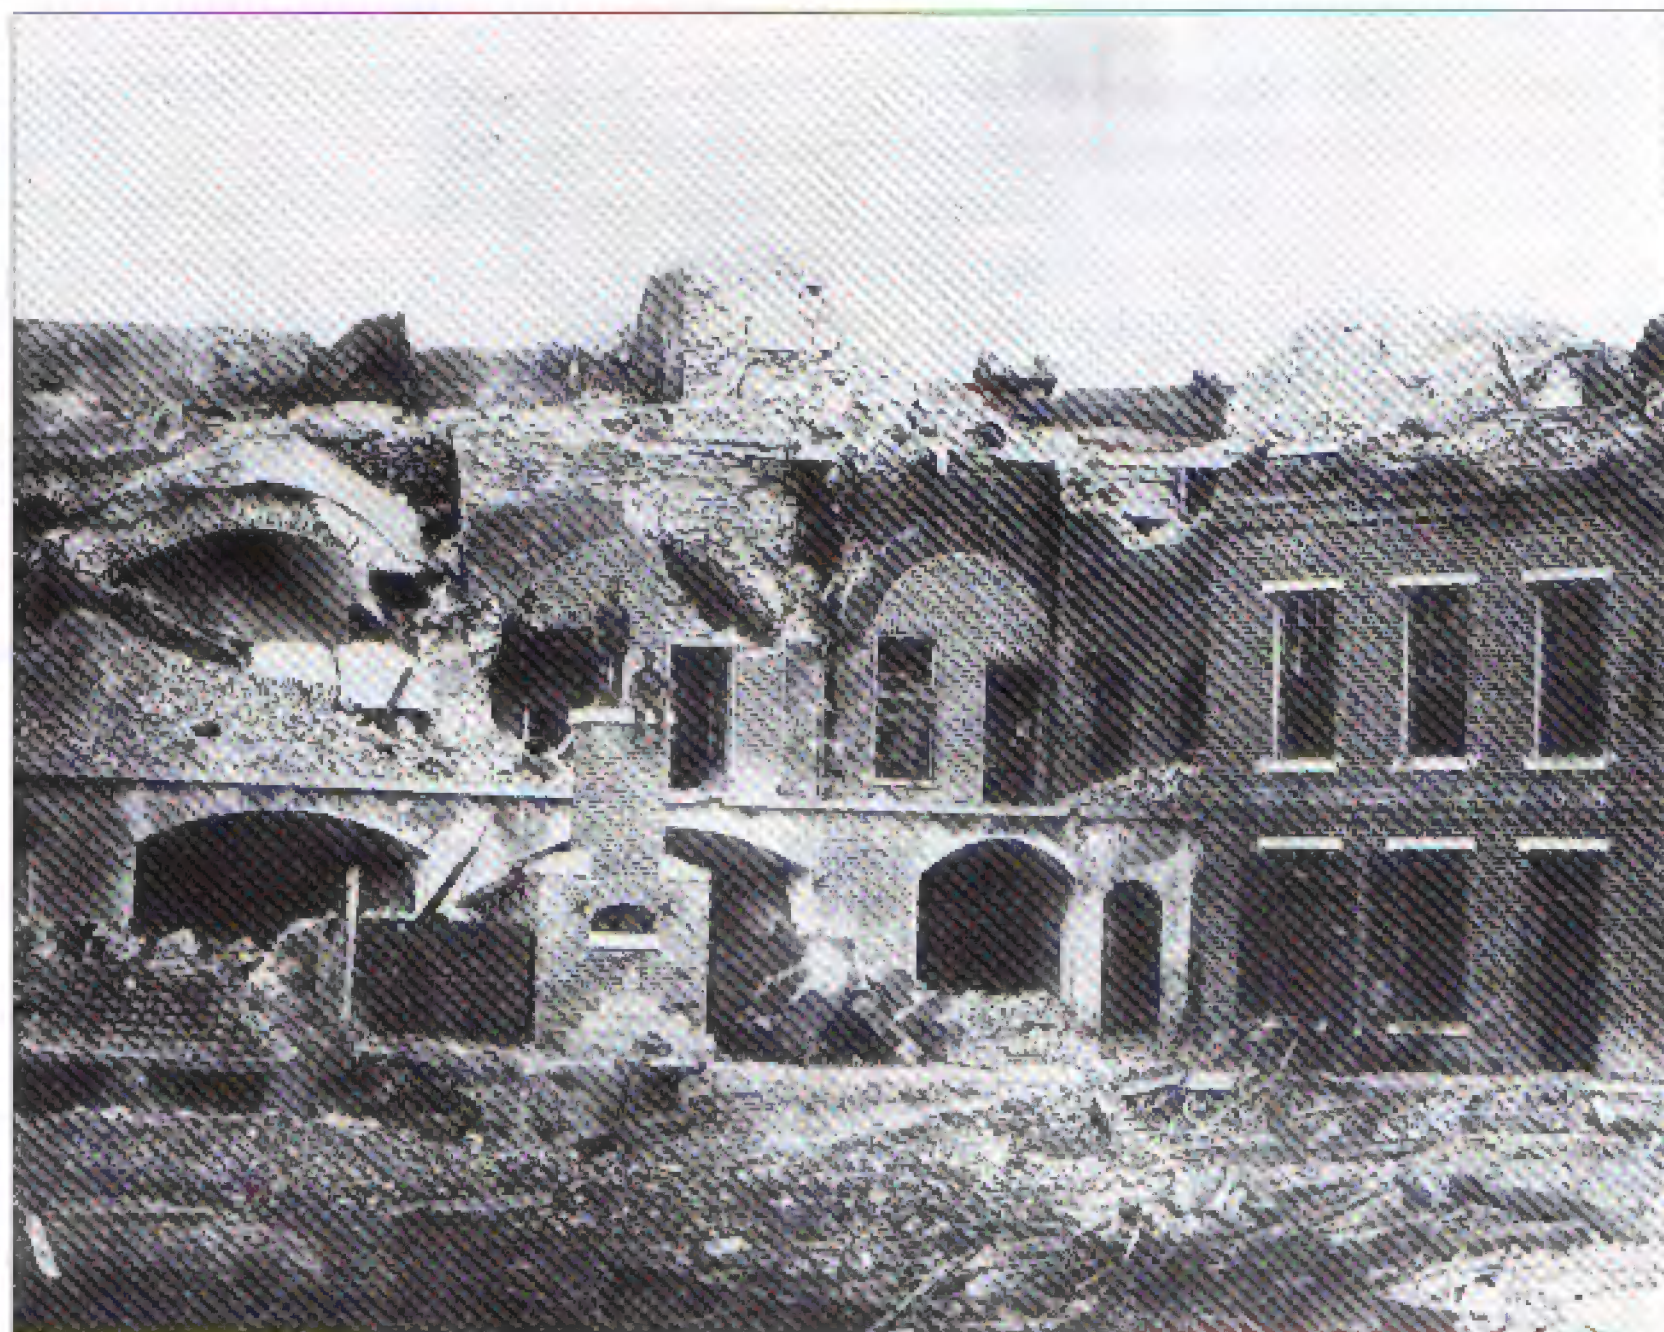
The interior of Fort Sumter photographed in September 1863. The hot-shot furnace appears undamaged, but the northeastern casemate wall and the casemate wall above it have suffered extensive damage. (Clyde Hensley Collection)

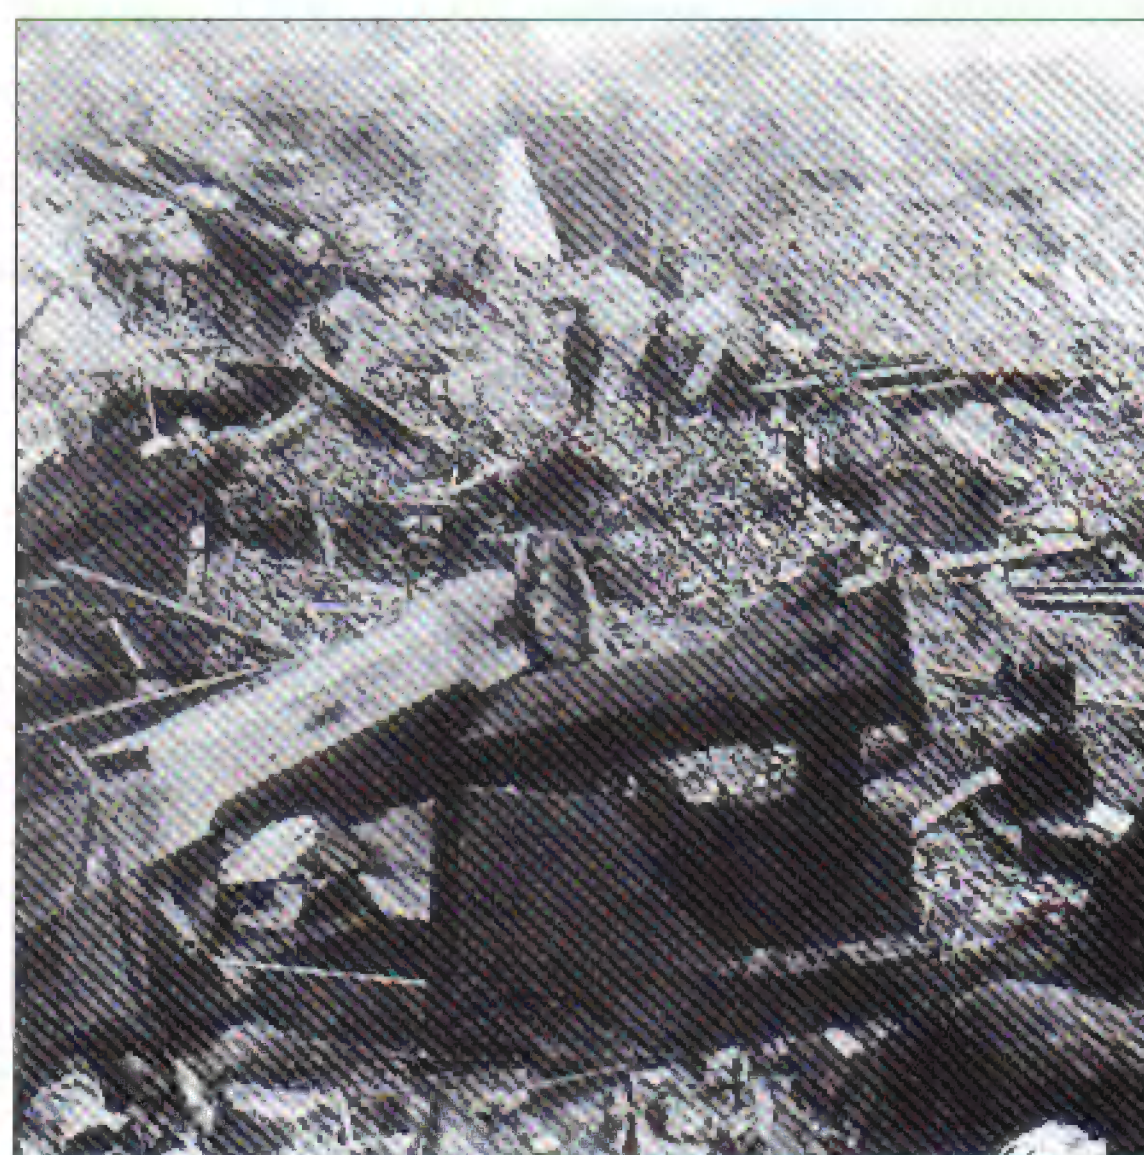
The interior of Fort Sumter photographed in December 1863. The two men in the photograph are standing on the site of the hot-shot furnace. (Clyde Hensley Collection)
